BEAVER BROOK, MORRIS COUNTY

SPLIT ROCK POND DAM

PHASE I INSPECTION REPORT NATIONAL DAM SAFETY PROGRAM

NJ 00264

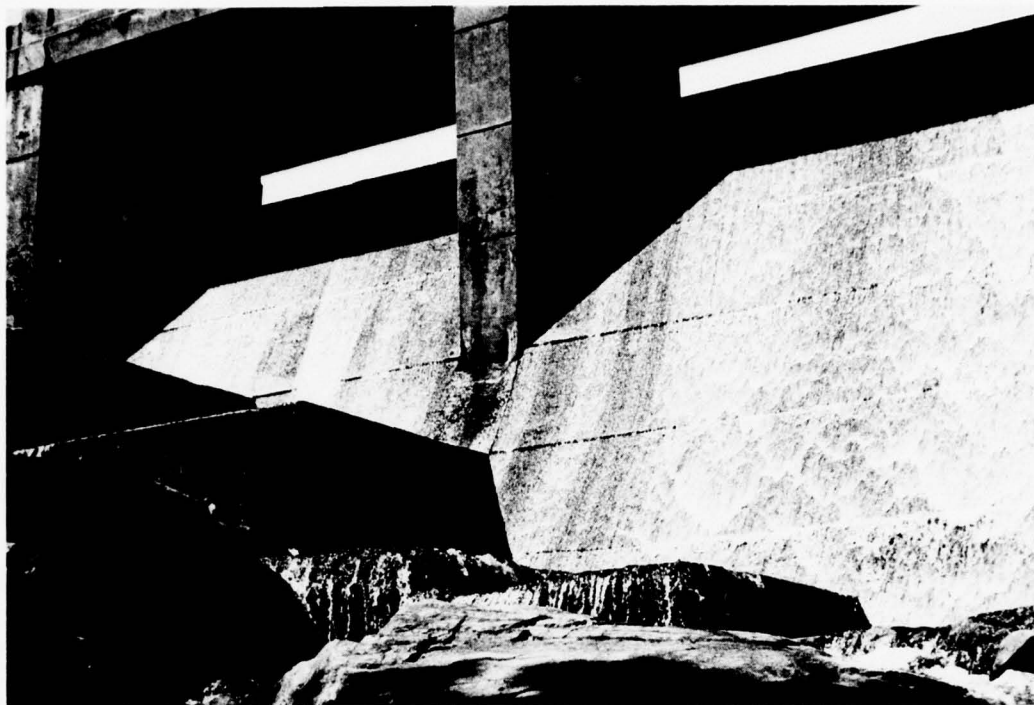
PHOTO 5

Photo 5 - View Upstream (North) at Spillway From Right (West) Bank - Gneiss Foundation Rock at Bottom of Photo - 15 June 1978.

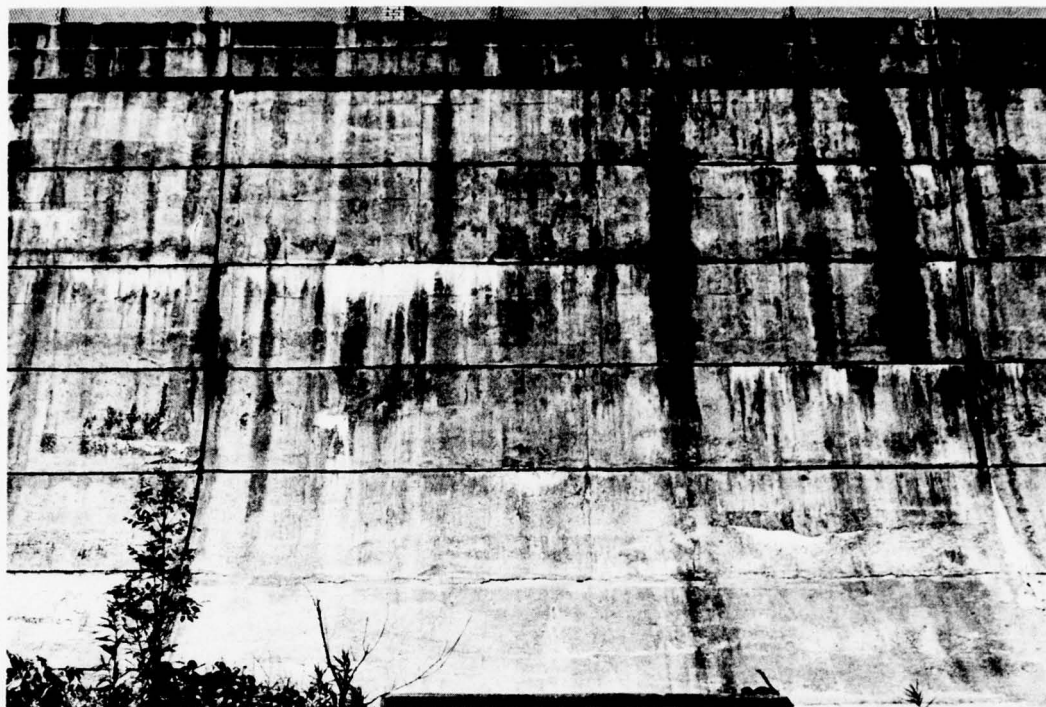
PHOTO 7

- b. Dam - Considerable deterioration, i.e., cracking, spalling, leaching and mineral precipitation, was observed in most of the exposed concrete surfaces of the dam.

Minor leakage of water (presumably from the reservoir) was observed from several horizontal construction joints, vertical monolith joints, and miscellaneous cracks in the downstream face of the dam. None of these leaks was flowing at a perceptible rate and all leakage evaporated when the sun reached the downstream face of the dam.

Photo 7 - View Upstream (North) at Cracked, Spalled Concrete With Seepage and Mineral Deposits in Downstream Face of Dam - Dam Crest at Top Edge of Photo; Head Wall of 36 Inch Diameter Outlet Pipe in Bottom Center of Photo - 15 June 1978.

- a. Dam - As indicated in paragraph 3.1.a., it is impossible to assess, from the results of a visual inspection of this type, the extent to which concrete cracking, bulging, deterioration and leakage may affect the structural integrity of the dam. The nature and potential implications of these phenomena are such that the owner should immediately retain a properly qualified consultant to make more detailed investigations of structural aspects, including structural stability, of the dam as it presently exists and to develop plans and specifications for remedial work as necessary.

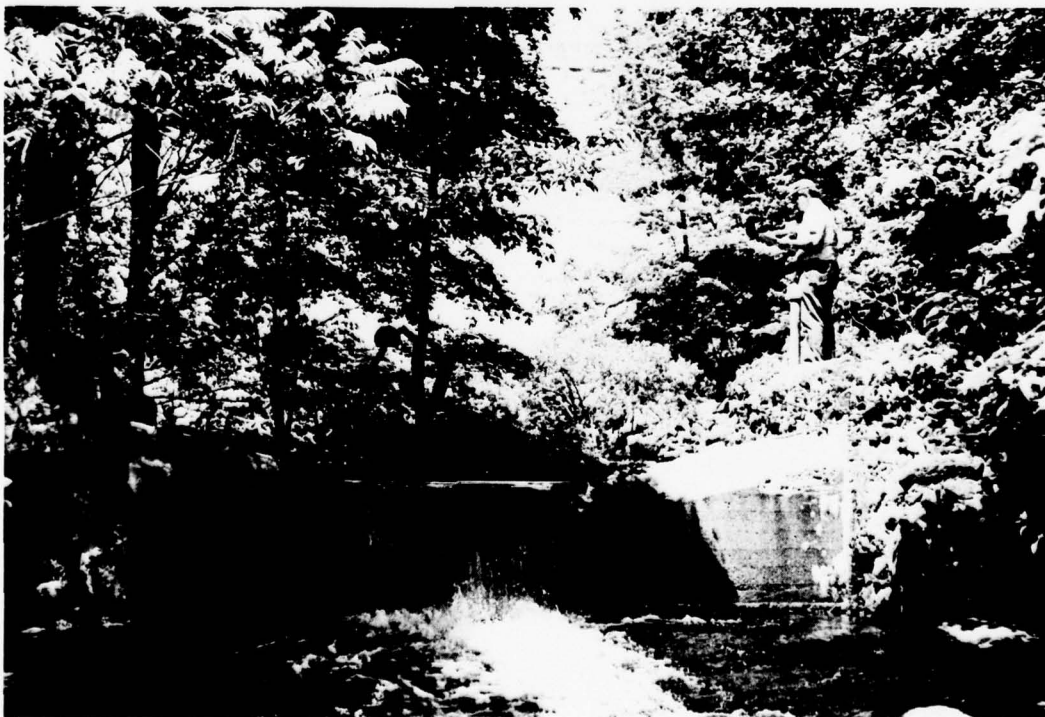
PHOTO 10

Photo 10 - Close-Up View Upstream at Concrete Weir in Outlet Channel 180 Feet Downstream From Dam (Top Center of Photo 9) - 36 Inch Diameter Outlet Pipe Is Dark Circle in Trees, Left Center of Photo Above Weir - 15 June 1978.

VISUAL EXAMINATION OF	OBSERVATIONS	REMARKS OR RECOMMENDATIONS
CONCRETE WEIR	Minor spalling of concrete was found on downstream side of the weir.

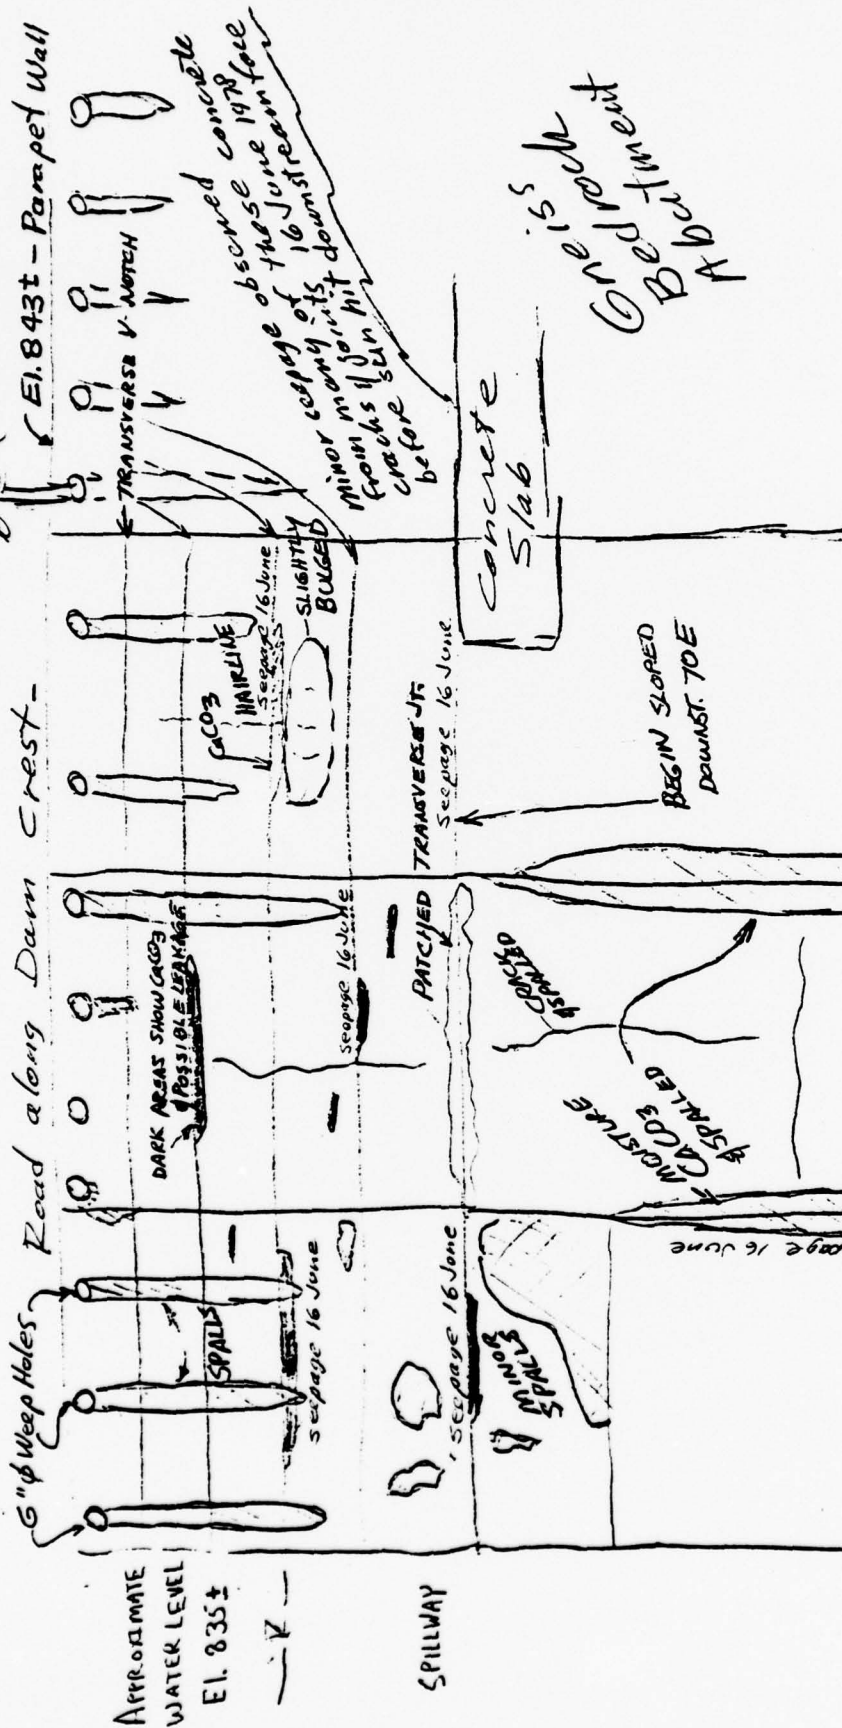
VISUAL EXAMINATION OF		OBSERVATIONS	REMARKS OR RECOMMENDATIONS
LEAKAGE		Minor leakage was observed through the horizontal (construction) and vertical (monolith) joints on the left (east) side downstream face of dam--see attached sketch. Minor leakage was observed through jointed rock in both abutments. The top of the leakage was located at approximately El. 820 on the right abutment and approximately El. 800 on the left abutment.	Leakage through concrete requires further investigation. Long term, steady state seepage of approximately one g.p.m. on each abutment is not considered detrimental to structural stability at time of inspection.
STRUCTURE TO ABUTMENT/EMBANKMENT JUNCTIONS		Concrete gravity dam has minor earth fill sections (height less than 10 feet) with concrete gravity retaining walls at both abutments (similar to bridge approach fills). No problems were observed.	
DRAINS		No foundation drains were constructed. Six inch diameter weep holes (some plugged with vegetation and small trees) drain water from subgrade of road along dam crest. Minor to major spalling of concrete was found beneath most of the weep holes on the upstream and downstream sides of dam.	Vegetation should be removed from weep holes to improve drainage and reduce concrete deterioration.

VERTICAL AND HORIZONTAL ALIGNMENT	There was a slightly bulged area (approximately 0.5 inches outward) noted in left side downstream face of dam approximately El. 830--see attached sketch. The bulged area was approximately three (3) feet high and ten (10) feet wide.	This bulge may be due to pressure of boulders or concrete against form-work during construction of cyclopean masonry, but bulge requires further investigation.
MONOLITH JOINTS	Some cracking, spalling, seepage and mineral deposits were noted along the vertical monolith joints.	
CONSTRUCTION JOINTS	Some cracking, spalling, seepage and mineral deposits were noted along the horizontal construction joints.

Seepage
 from Rock
 Joints - El. 800+
